## INSPECTION REPORT: GREENS CREEK MINE

Date of Inspection: Friday August 30, 2017  
Date of Report: Monday September 18, 2017  
USDA Forest Service Inspector: Richard Dudek

Ranger District: Admiralty National Monument, Juneau Ranger District  
Weather Conditions: Partly Cloudy Temperature: mid 50's (°F).

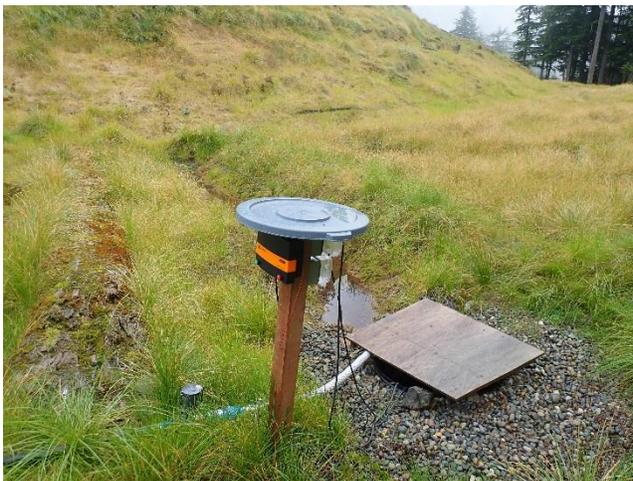
**Photo 1. The 1350 trench and pump.**

The trench and pump are working as intended (Photo 1), and HGCMC Surface operations are maintaining the portal (Photo 2) which is primarily used for ventilation, and as a secondary escape way.

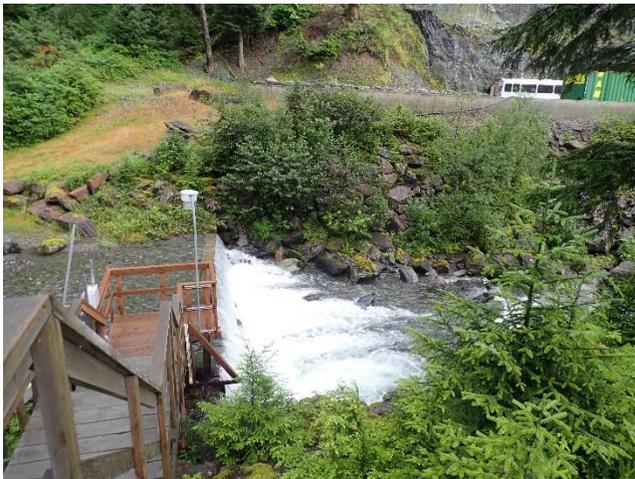
**Photo 3. The Greens Creek weir in the 920 area.**

The recorded flow rate for Greens Creek (Photo 3) on 08/30/2017 was 42.45 cubic feet per second (cfs), and the water withdrawal for the 920 water system remains at 1.5 cfs.

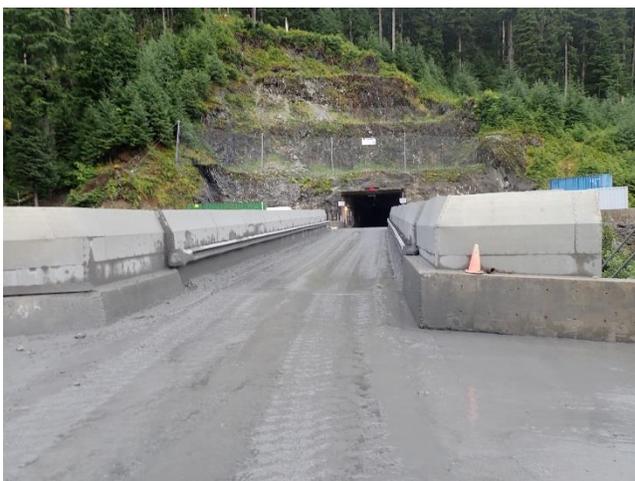
**Photo 4. The 920 Bridge.**

HGCMC Surface operations are properly maintaining the 920 Bridge (Photo 4), and the sedimentation at both bridge ends was minimal.

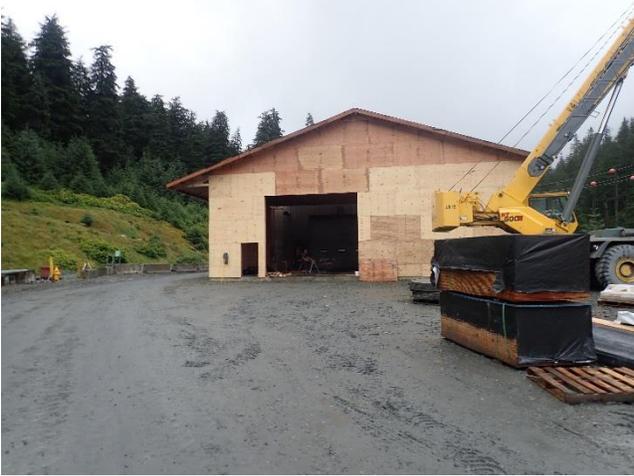
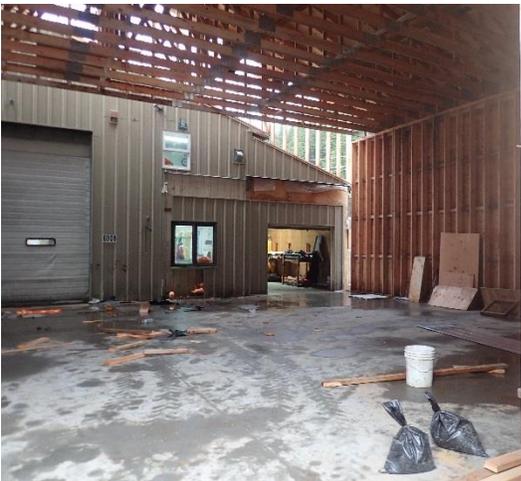
At the time of the inspection, contractors were working on the 920 warehouse expansion, which will increase storage by 2,080 square feet (Photos 5-6).

**Photo 5. The 920 warehouse expansion (Image 1 of 2).**

**Photo 6. The 920 warehouse expansion (Image 2 of 2).**

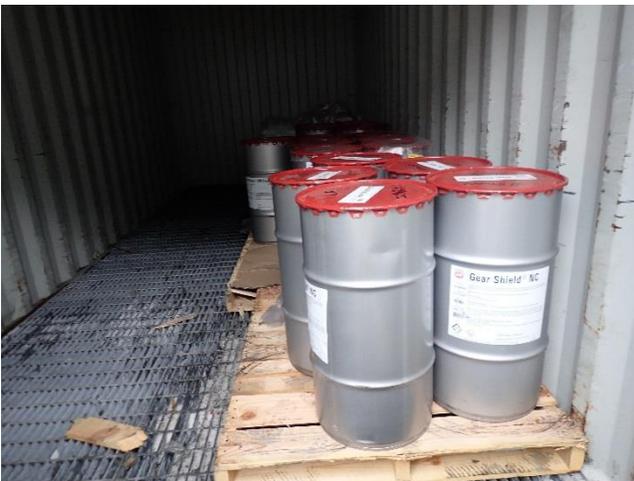
The 920 warehouse storage area (Photo 7) was tidy and in order (Appendix 5 BMP Plan; pages 39-40).

**Photo 7. A 920 warehouse storage container provides secondary containment for petroleum products.**

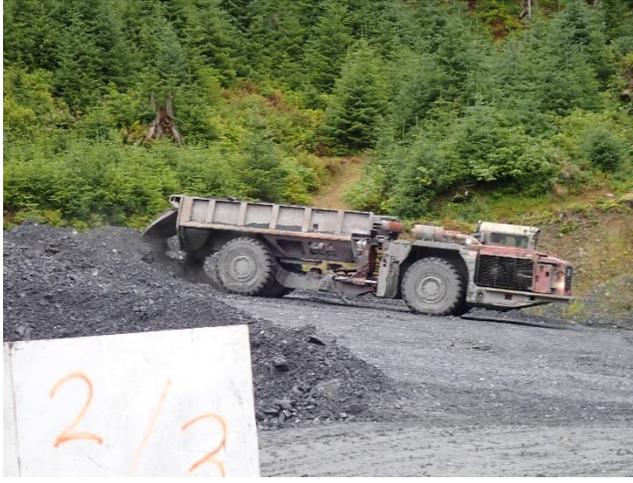
During the site inspection, additional Class 1 waste rock (Photo 8) was being deposited (Appendix 1; Section 3.1).

**Photo 8. Class 1 waste rock being deposited at the Class 1 waste rock stockpile.**

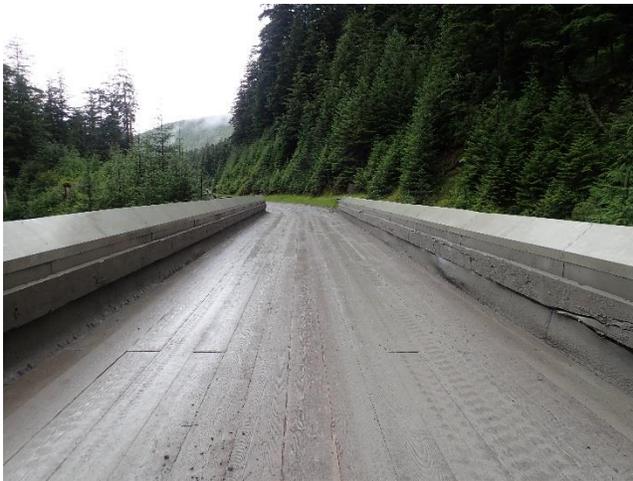
**Photo 9. 7.4 mile B-road Bridge (Killer Creek Bridge).**

Surface operations are maintaining the bridge (Photo 9), and the splashguards (Photo 10) are effectively preventing sediment splash-over from vehicle traffic. The downhill side abutment (Photo 11) has established vegetation, which will help stabilize the slope (Appendix 5 BMP Plan; page 13).

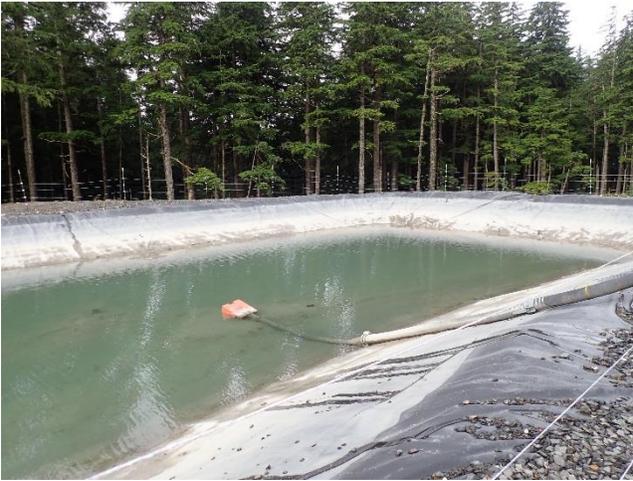
**Photo 12. Site E collection pond.**

This site is an inactive waste rock storage area (Appendix 11 Waste Rock Management Plan, Section 2.4 Table 2). HGCMC personnel are properly maintaining the collection pond and the electric fence around the pond's perimeter (Photo 12).

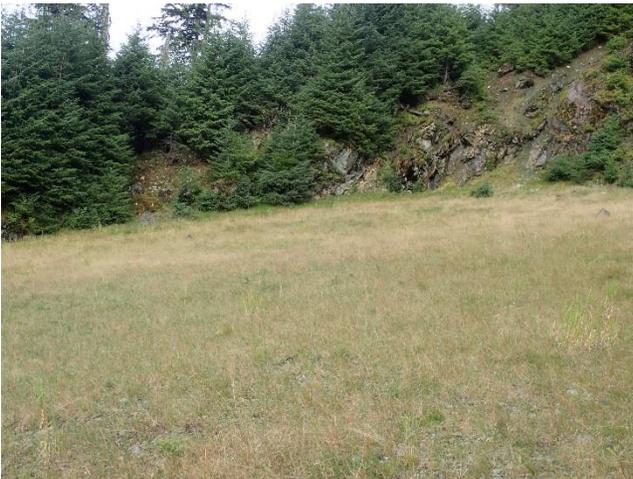
**Photo 13. Pit 6 located at 4.6 mile B-road.**

This is an inactive site (Photo 13). The reclaimed area has established vegetation and was contoured for stormwater runoff. Stormwater monitoring site 547 SW (Photo 14) is located downgradient from the pit, and is part of HGCMC's APDES monitoring program.

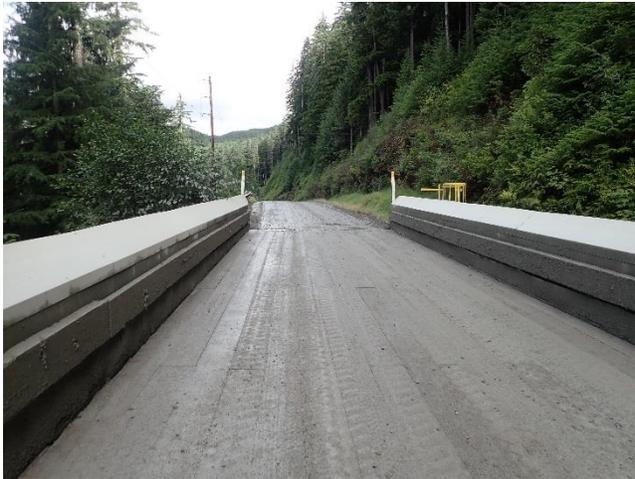
**Photo 15. 3.4 mile B-road Bridge (Falls Creek Bridge).**

HGCMC personnel are maintaining the bridge (Photo 15), and the splashguards are preventing sediment splash-over into the creek (Photo 16). Residual sediments from surface water runoff remain underneath the bridge (Photo 17).

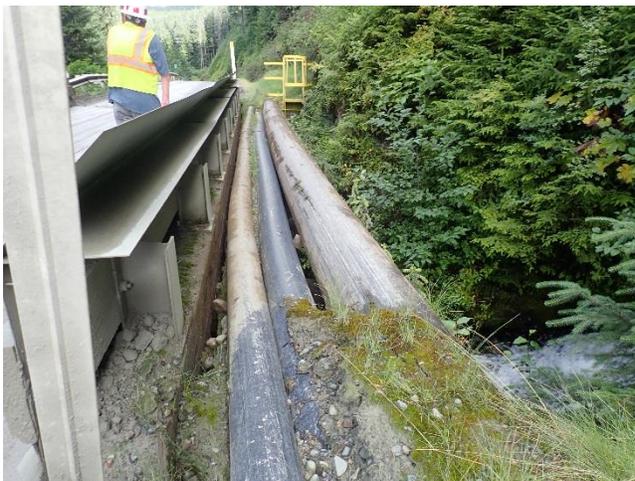
**Photo 16. Falls Creek Bridge's splashguards are effectively working by preventing sediment splash over.**

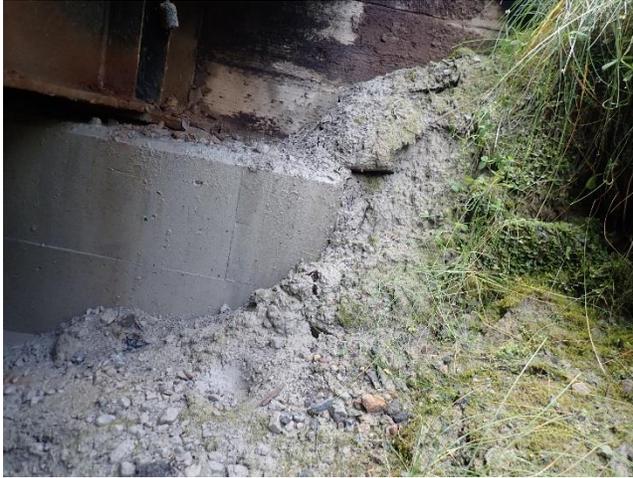
**Photo 17. Residual sediments observed underneath Falls Creek Bridge.**

**B-road bridges sediment accumulation and the inspection of the BMP's at the bridge.**

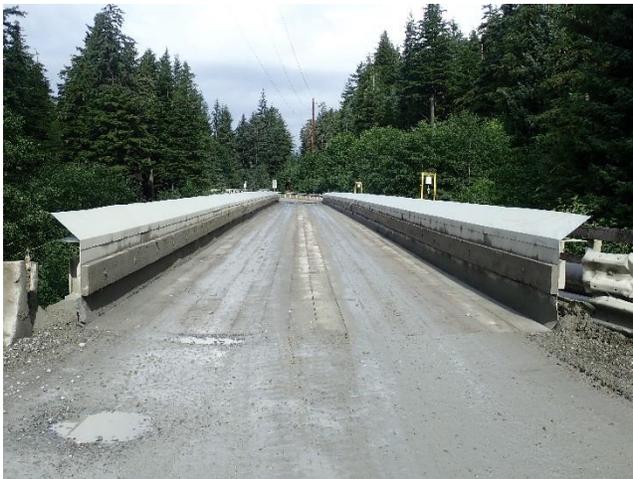
**Photo 18. 3.0 mile B-road Bridge (Zinc Creek Bridge).**

HGCMC personnel completed the re-decking and relining of the bridge (Photo 18) on August 10, 2017.

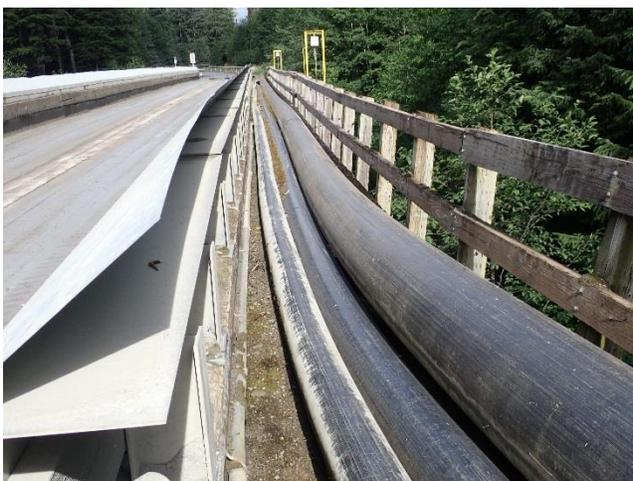
**Photo 19. One side of the Zinc Creek Bridge's splashguard.**

The splashguards (Photo 19) are preventing sediment splash-over into the creek, and the structural BMPs located on the uphill/downstream side of the bridge are functioning as intended (Photo 20). HGCMC Surface operations have a tentatively scheduled plan to clean the abutment drain where a white precipitate is steadily dripping onto the ground (Photo 21). After the drain is cleaned out, the accumulation of white substance will be monitored.

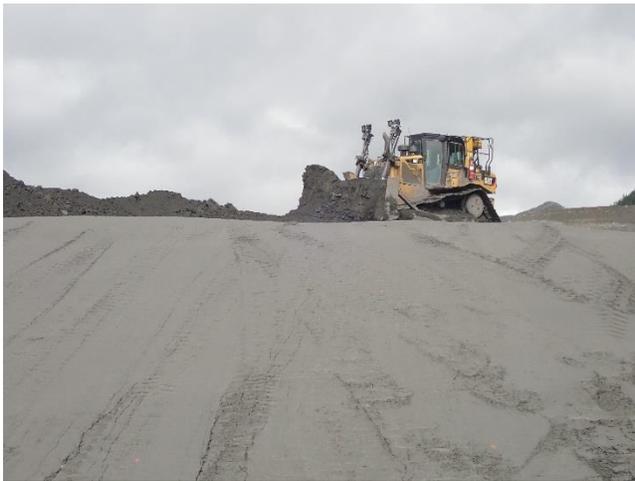
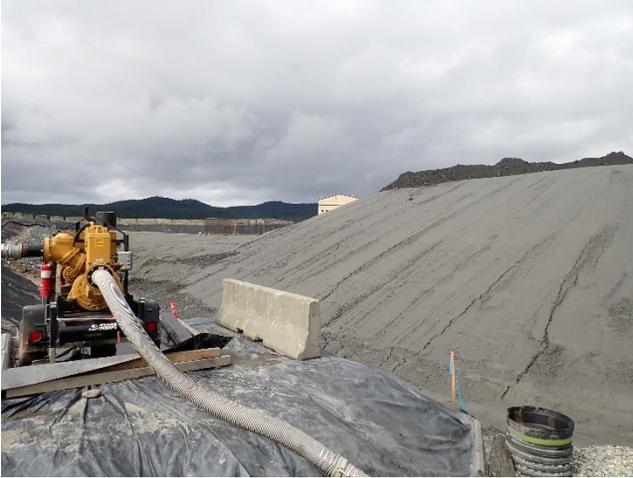
HGCMC continues to deposit tailings in the TDF S3P1 area (Photos 22-23). HGCMC is currently engaged with the Alaska Department of Natural Resources (ADNR) Alaska Dam Safety Program for authorization to use Pond 10 (Photo 24) and the concrete flow control structure (Photo 25).

**Photo 22. HGCMC TDF personnel were actively placing tailing in the S3P1 area.**

**Photo 23. Southern area of the S3P1 expansion area (TDF area).**

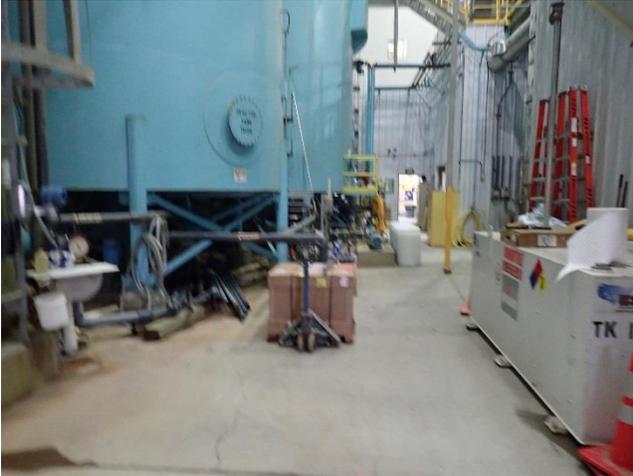
**Photo 26. HGCMC's water treatment plant at the TDF.**

At the time of this inspection, the water treatment plant was discharging 1,554 gallons of water per minute (gpm) through Outfall 002. All treated/discharged water through this Outfall is limited and monitored per APDES permit requirements. The water treatment (Photo 26) plant was tidy and in order (Appendix 5 BMP Plan; pages 39-40).

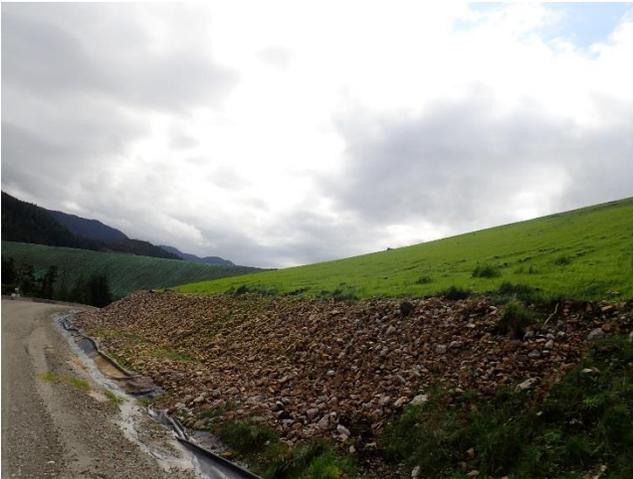
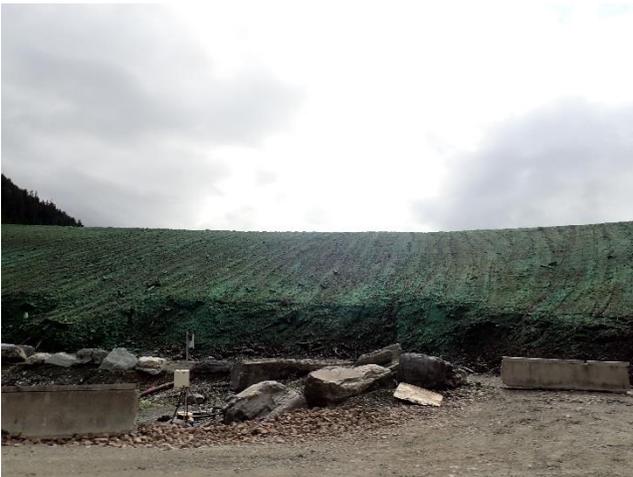
HGCMC personnel continue to hydroseed the northwest slopes (Photos 27-28) of the TDF. The established vegetation will help soil stability, and minimize erosion damage to the slopes (Appendix 5 BMP Plan; page 13).

**Photo 27. Vegetative cover for slopes in the northern TDF area.**

**Photo 28. HGCMC TDF personnel recently applied hydroseed to the TDF slopes near pond 9.**

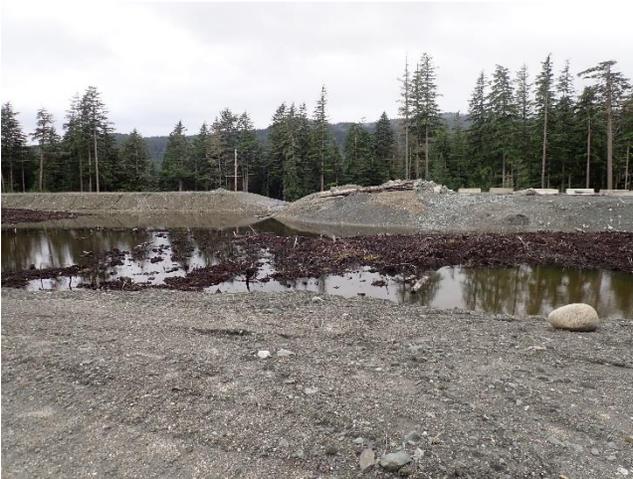
**Photo 29. The Sand pit located at 1.4 mile A-road.**

This site is currently inactive (Photo 29).
